# One-mm 3D Laser Imaging Survey for Comprehensive Runway Evaluation

**Joshua Q. Li, Kelvin C. P. Wang, Guangwei  
Yang, and Lin Li**

**Oklahoma State University**

**2014 FAA Worldwide Airport Technology  
Transfer Conference**

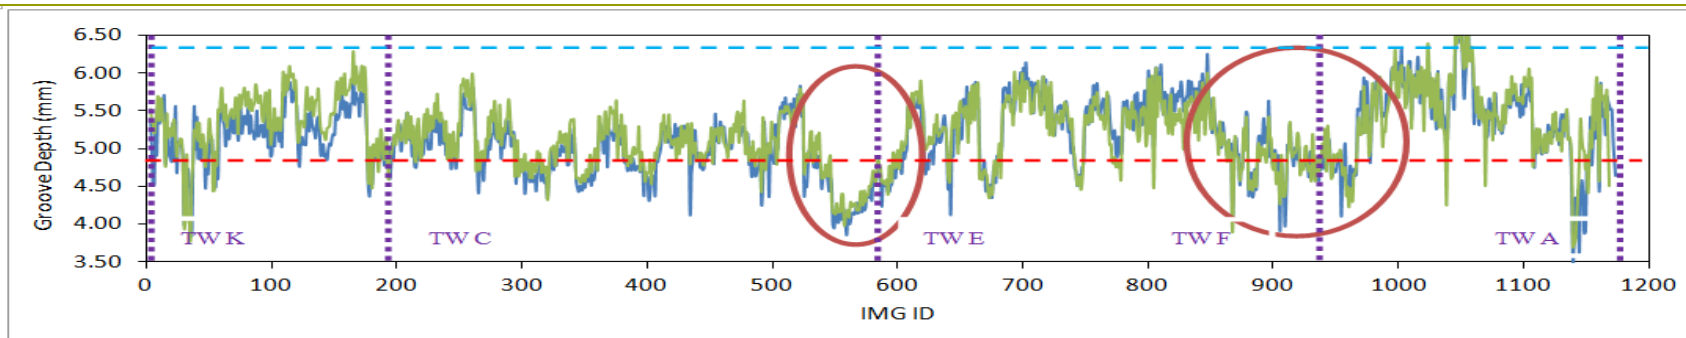
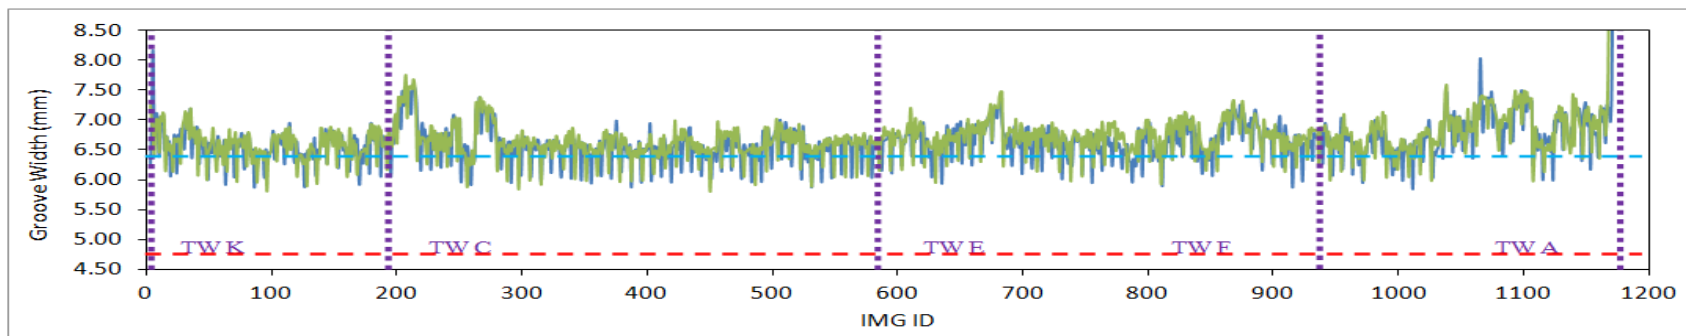
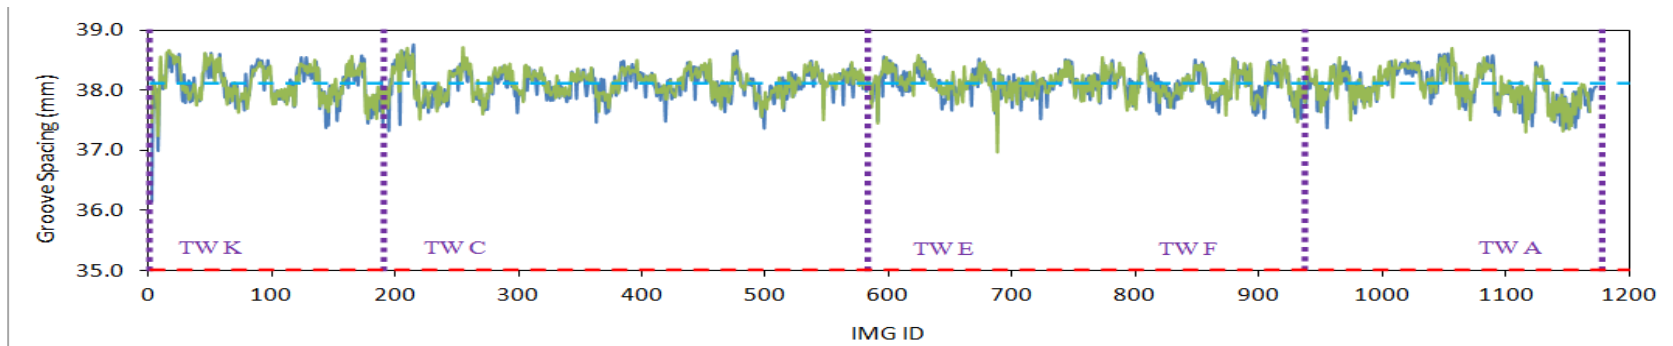
# Groove Evaluation (Slab 4 Runs 7&8)

(a) Groove Depth

(b) Groove Width

(c) Groove Spacing
